## PROJECT REPORT CPR2035

### Independent Review of Decisions Involving Safety Barrier at the Junction of Sans Souci Park and Malone Road, Belfast

**Project Ref:** PSDRD 41/15

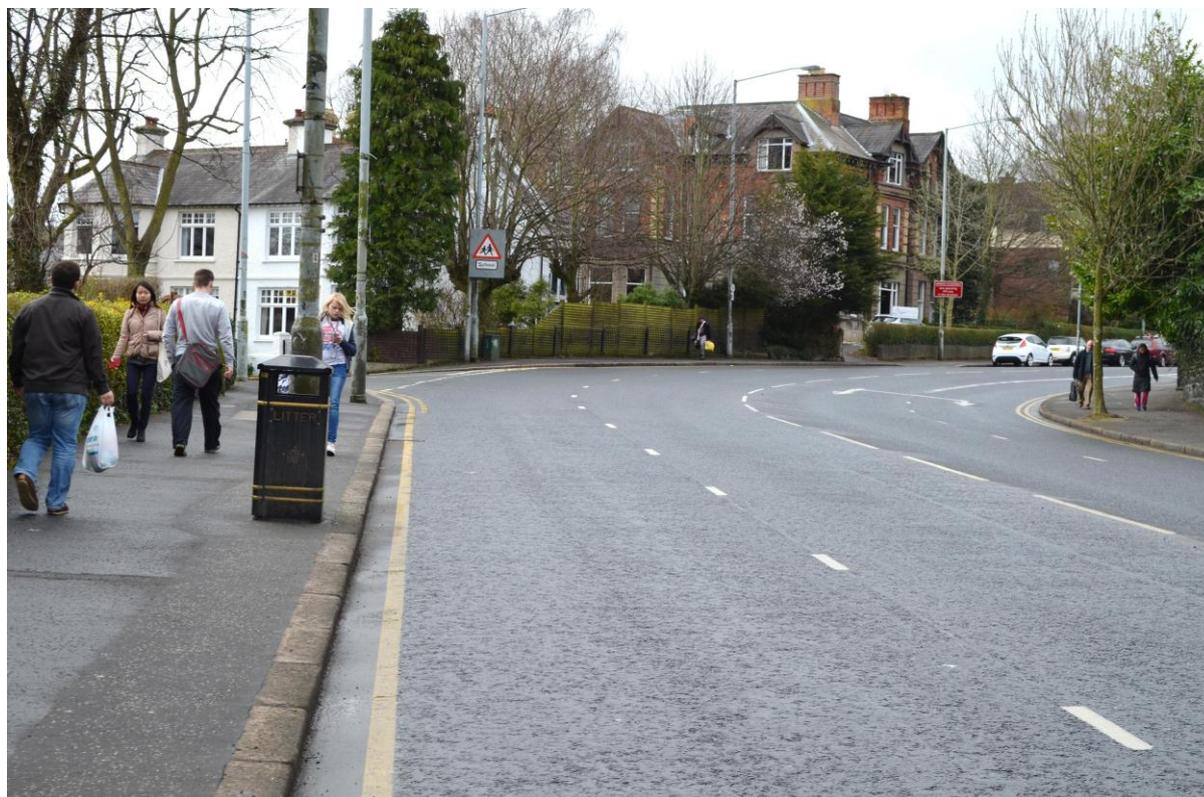
**Figure 1: Approach to the Malone Road and Sans Souci Park junction**

1.5 Site Characteristics	15	3 * <sup>1</sup>	5	At the material location there is a radius with a hazard (housing) on the outside of a bend - refer to Figure 1
<b>Section 1 Total:</b>		<b>9</b>	<b>17.5</b>	
<b>Section 2: Practicality</b>
