# Bathing Water Profile Portstewart

May 2016

#### A Description of Portstewart Strand and the surrounding area

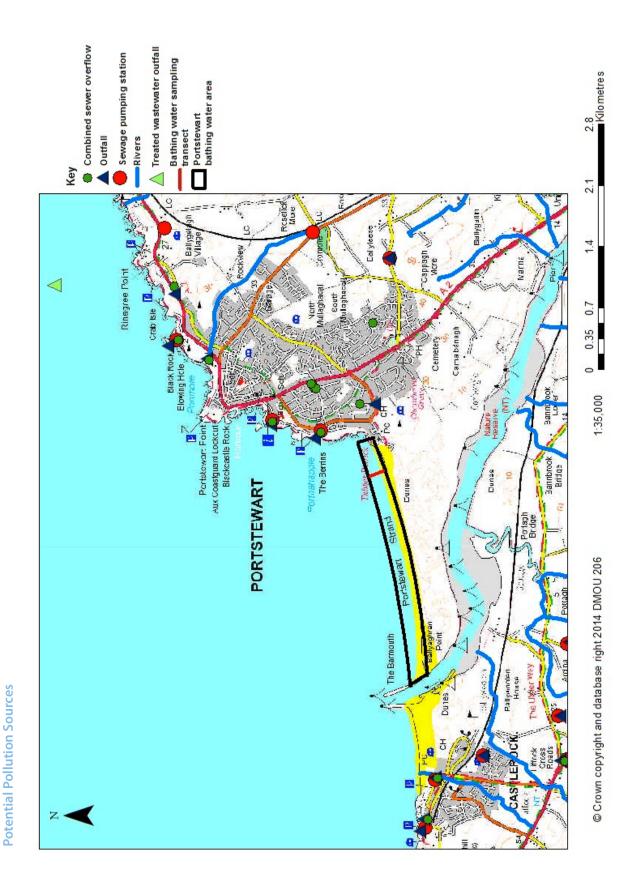
Map 1

Portstewart Bathing Water -

The River Bann flows out to sea at the western end of the beach through the Barmouth (see Map 1). The River Bann flows primarily through rural areas with agriculture being the main land use, draining some 40% of Northern Ireland. However it also flows through several towns including Coleraine, Portglenone and Toome.

There is a major waste water treatment facility between Coleraine and Portstewart with an outfall approximately 1 km off the coast (see Map 1), to the east of Portstewart. This treated waste water outfall is approximately 4 km from the Portstewart bathing water. The works treats waste water from the wider Portrush, Portstewart and Coleraine area. The waste water receives secondary treatment.

Portstewart town is a very popular seaside location attracting large numbers of visitors during the summer season. This urbanisation is a potential source of pollution, especially during and after periods of prolonged or heavy rainfall. In the event of very heavy rainfall a collection system may not be able to deal with all of the flow received. A portion of the contents of the collection system may overflow to a waterway under storm conditions. This is why there is general advice not to bathe during or up to 2 days after such rain. The municipal collection and treatment of waste water has the potential to cause pollution because all collection systems must be designed to overflow in periods of extreme wet weather or following failure of a pump system. If systems are not designed in that way, then sewers may overflow into residential areas. Within the Portstewart and Coleraine area there are combined sewer overflows, emergency overflows and sewage pumping stations with associated emergency overflows. All of these are shown on Map 1. NIW has in the past made significant improvements

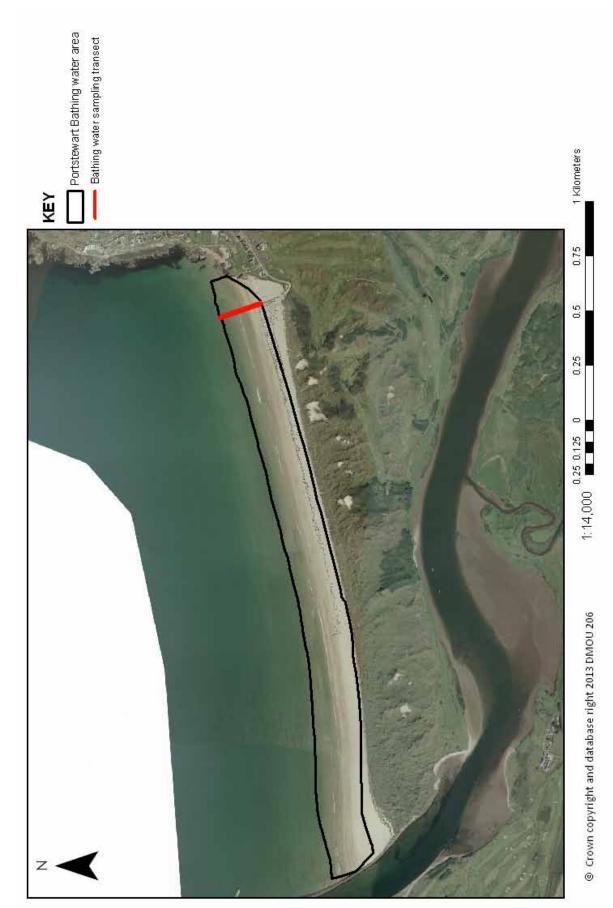
Bathing Water Name	Portstewart Bathing Water
EU bathing water ID number	UKNO4_48900
Location	UK/Northern Ireland/County Londonderry/North Coast
Year of identification	1993
Local council area	Causeway Coast and Glens Borough Council
Bathing Water Operator	The National Trust
Description of bathing beach	Sand, approximately 3 kilometres in length
Monitoring Point	At east end near main access point, C 8087 3677, (Map 2)
