Bathing Water Profile

Carnlough

May 2018

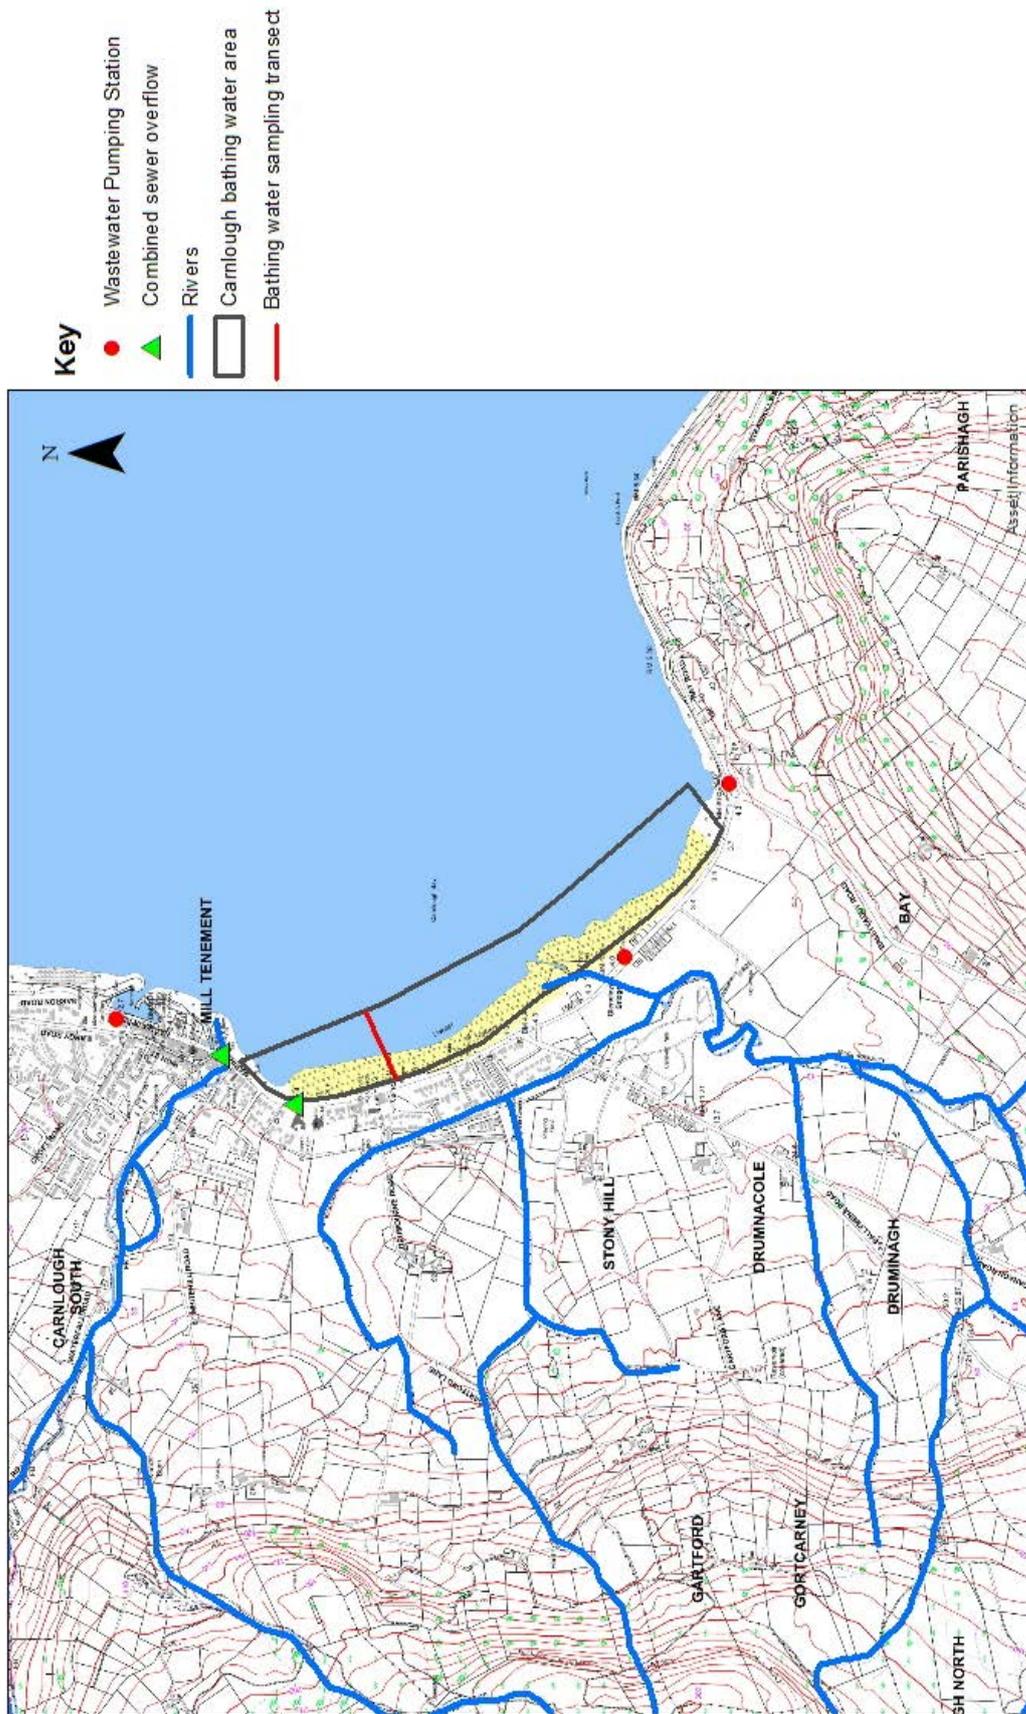
Map 1
Carnlough Bathing Water -
Potential Pollution Sources

following failure of the system. If systems are not designed in that way, then sewers may overflow into residential areas. Within Carnlough bathing area there are combined sewer overflows (CSO), emergency overflows and waste water pumping stations with associated emergency overflows as shown on Map 1.

The urbanisation associated with the village of Carnlough, is a potential source of pollution, especially during and after periods of prolonged or heavy rainfall. In the event of very heavy rainfall a collection system may not be able to deal with all the flow received. A portion of the contents of the collection system may overflow to a waterway under storm conditions. [This is why there is general advice not to bathe during or up to 2 days after such rain.](#)

The municipal collection and treatment of waste water has the potential to cause pollution because all combined collection systems must be designed to overflow in periods of extreme wet weather or

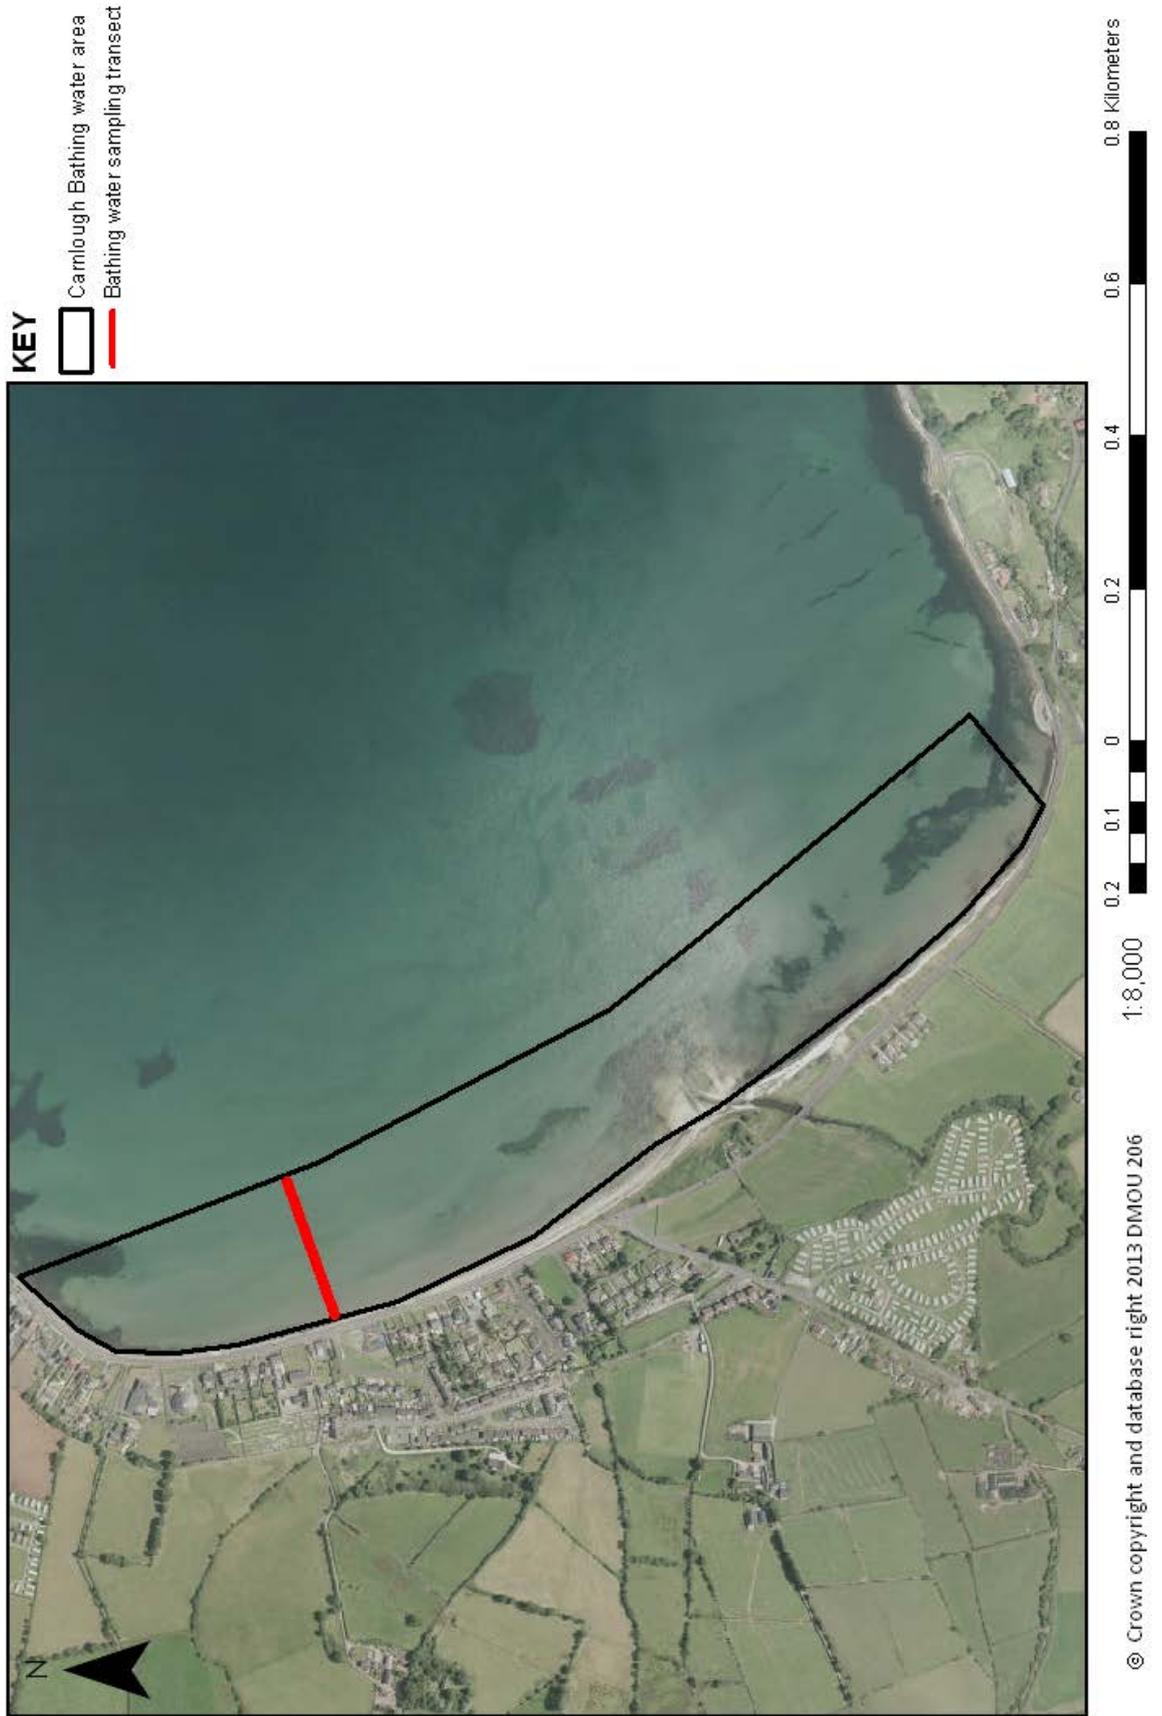
Map 2
Carnlough Bathing Water -
EC Bathing Water Sample Location

Bathing Water Name	Carnlough Bathing Water
EU bathing water ID number	UKNO5_50900
Location	UK/Northern Ireland/County Antrim/Antrim Coast
Year of identification	2006
Local council area	Mid and East Antrim Borough Council
Bathing Water Operator	Mid and East Antrim Borough Council
Description of bathing beach	Mainly sand with some rocky outcrops and pebbles, 1.5 kilometres in length.
Monitoring Point	Northern end of bathing water, D28601737 (Map 2)
