# Bathing Water Profile

## Downhill

May 2018

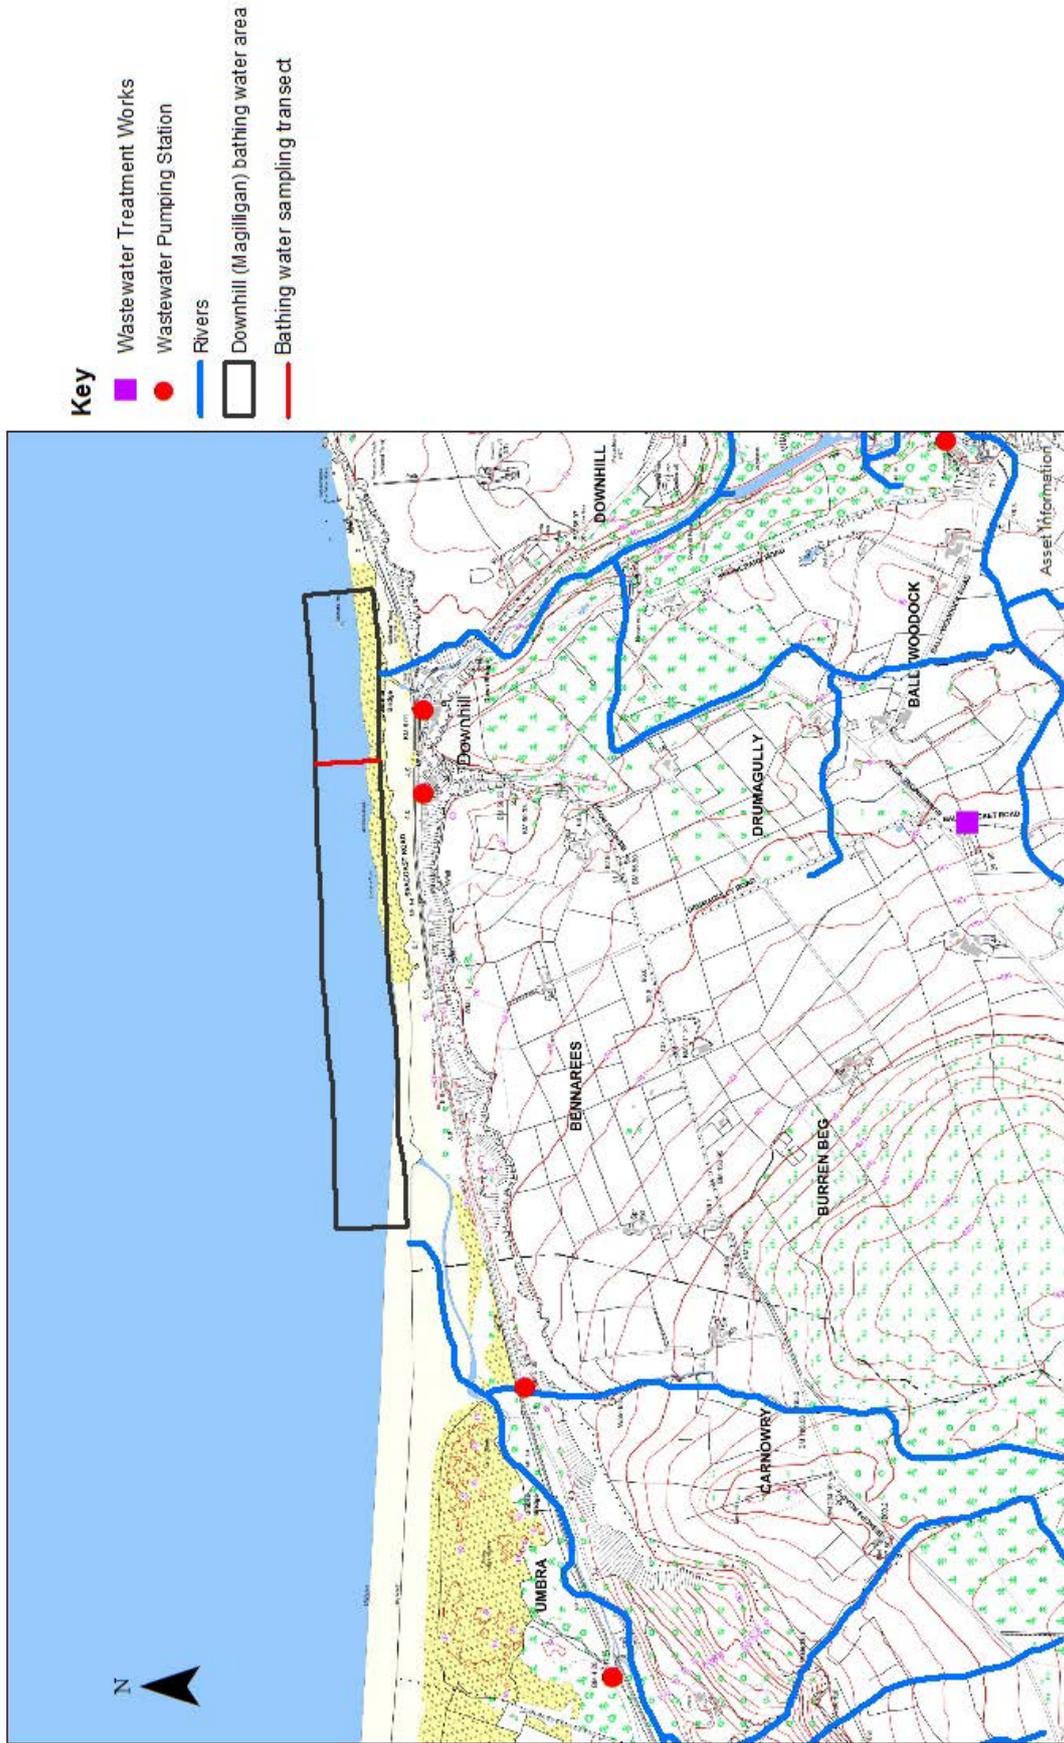
Map 1  
Downhill Bathing Water -  
Potential Pollution Sources

There is a small waste water treatment works less than 2 km from the bathing water (Map 1). The majority of sewage generated in this area is treated at the new WWTW approximately 10kms west of the bathing water.

The municipal collection and treatment of waste water has the potential to cause pollution because all collection systems must be designed to overflow in periods of extreme wet weather. If systems are not designed in that way, then sewers may overflow into residential areas. Within the Downhill area there are wastewater pumping stations with associated overflows as shown on Map 1.

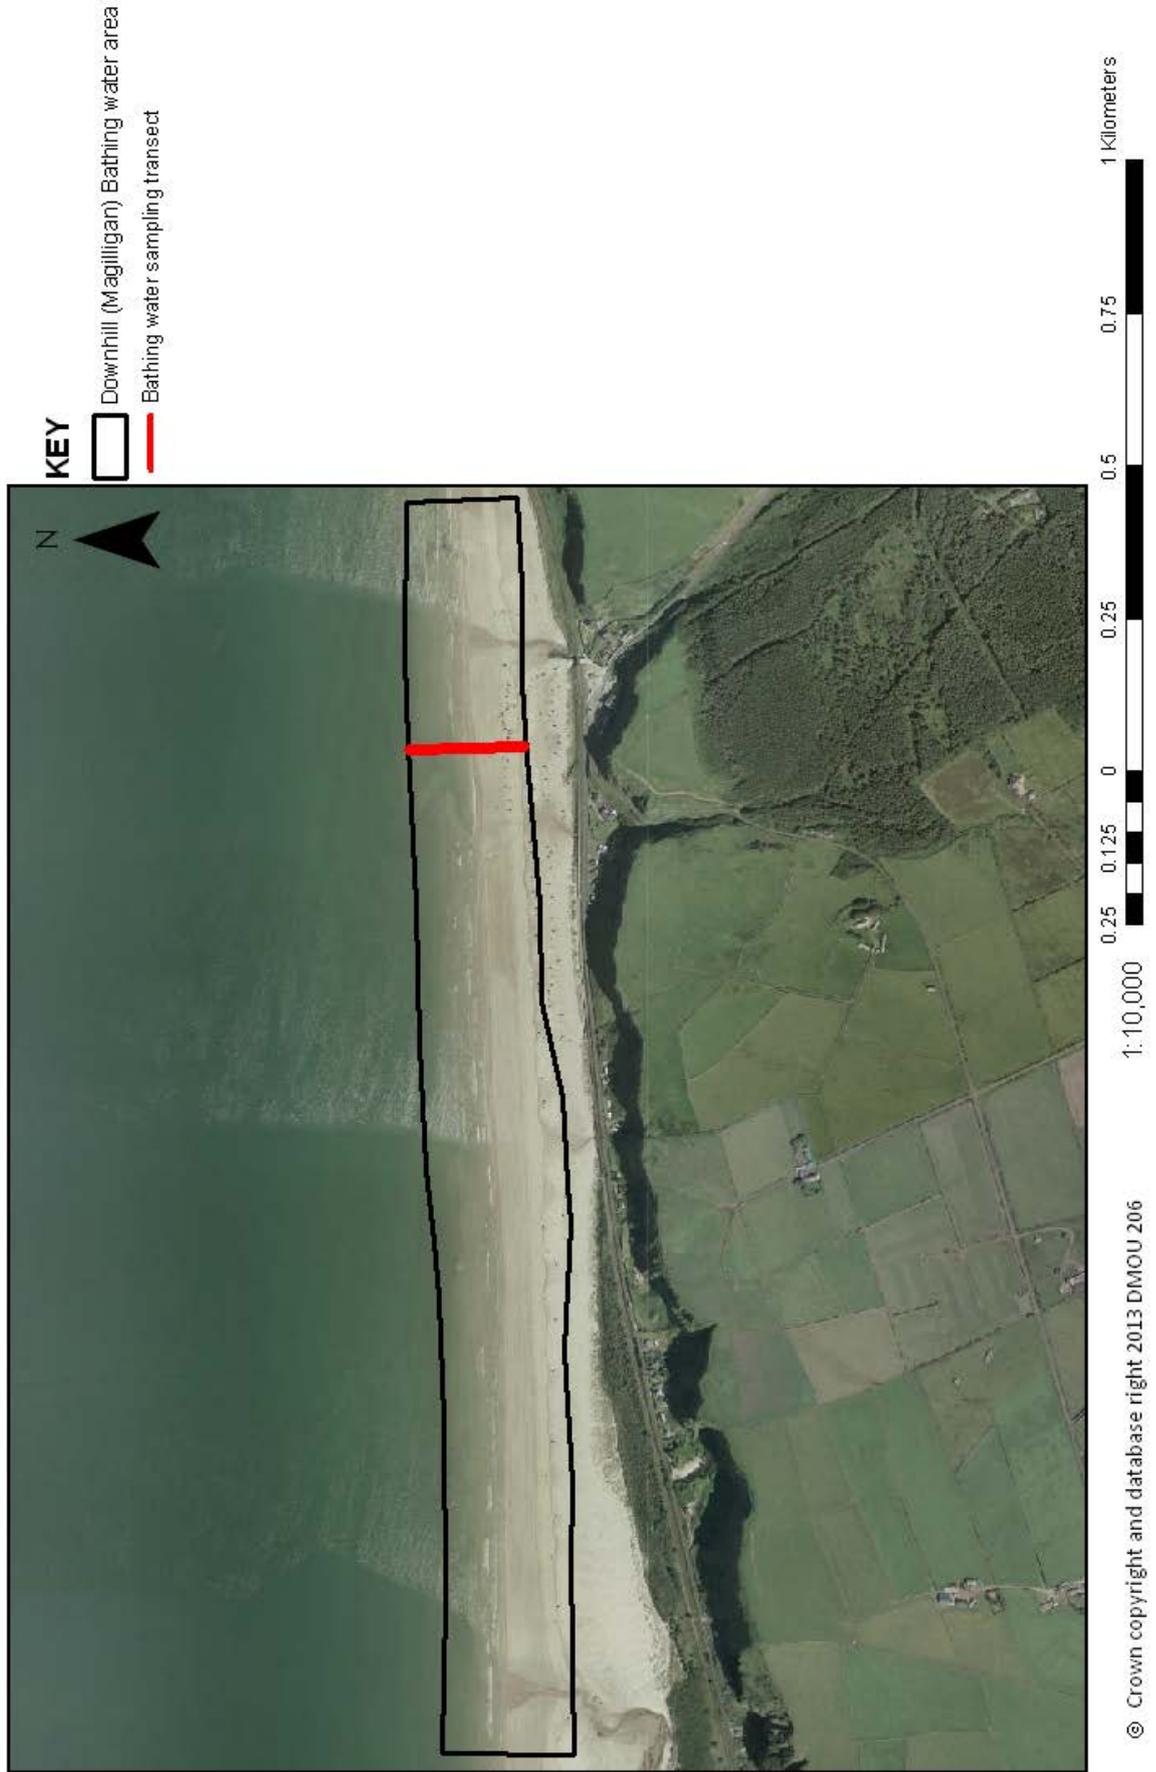
Map 2  
Downhill Bathing Water -  
EC Bathing Water Sample Location

<b>Bathing Water Name</b>	Downhill Bathing Water
<b>EU bathing water ID number</b>	UKNO4_47500
<b>Location</b>	UK/Northern Ireland/County Londonderry/North Coast
<b>Year of identification</b>	2006
<b>Local council area</b>	Causeway Coast and Glens Borough Council
<b>Bathing Water Operator</b>	Causeway Coast and Glens Borough Council
<b>Description of bathing beach</b>	Sand, 4 kilometres in length, contiguous with Benone Bathing Water
<b>Monitoring Point</b>	West of cemented access onto beach, C 7503 3627, (Map 2)
