Bathing Water Profile

Cranfield Bay

May 2022

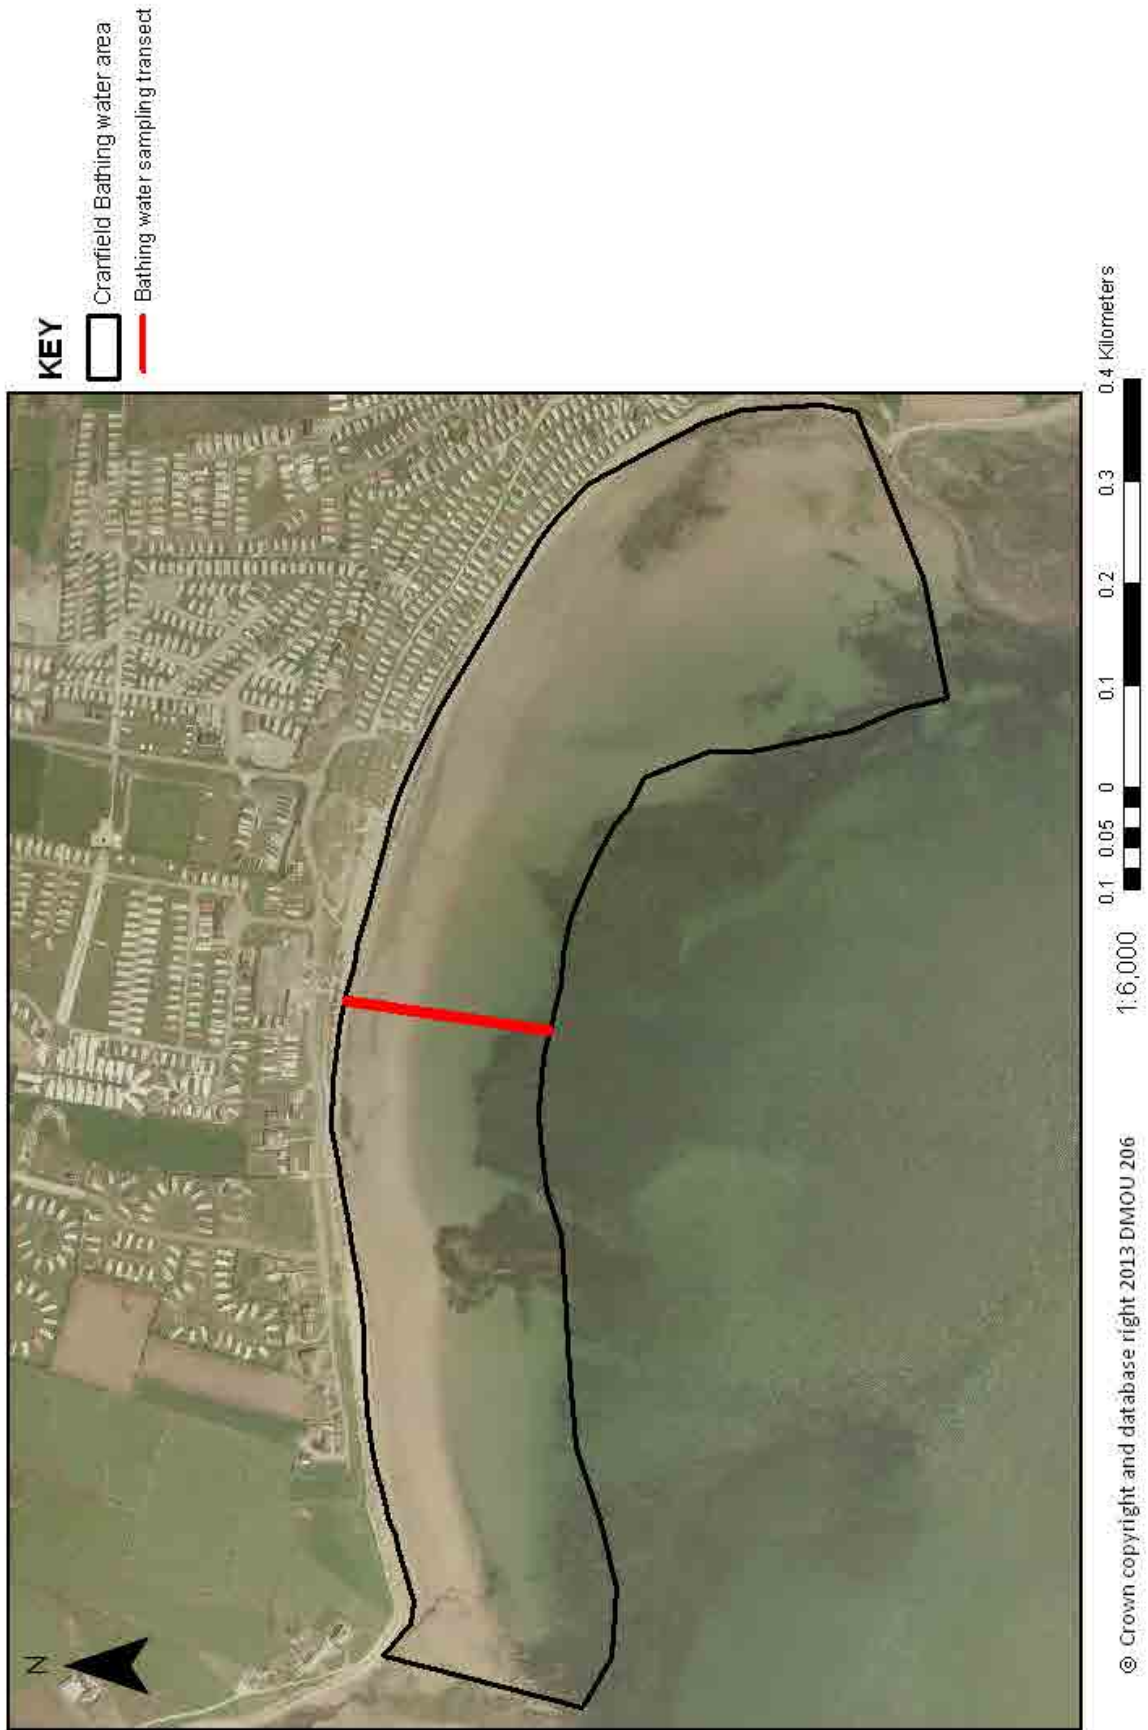
Map 2
Cranfield Bay Bathing Water -
EC Bathing Water Sample Location

Bathing Water Name	Cranfield (Cranfield Bay) Bathing Water
Location	UK/Northern Ireland/County Down/South Down Coast
Year of identification	1988
Local council area	Newry, Mourne and Down District Council
Bathing Water Operator	Newry, Mourne and Down District Council
Description of bathing beach	Sand and pebbles, approximately 1.5 kilometres in length
Monitoring Point	Middle of bathing water, J26371066 (Map 2)
